Heritage-listed Church Restored

Church building

Dalby, QLD, Australia

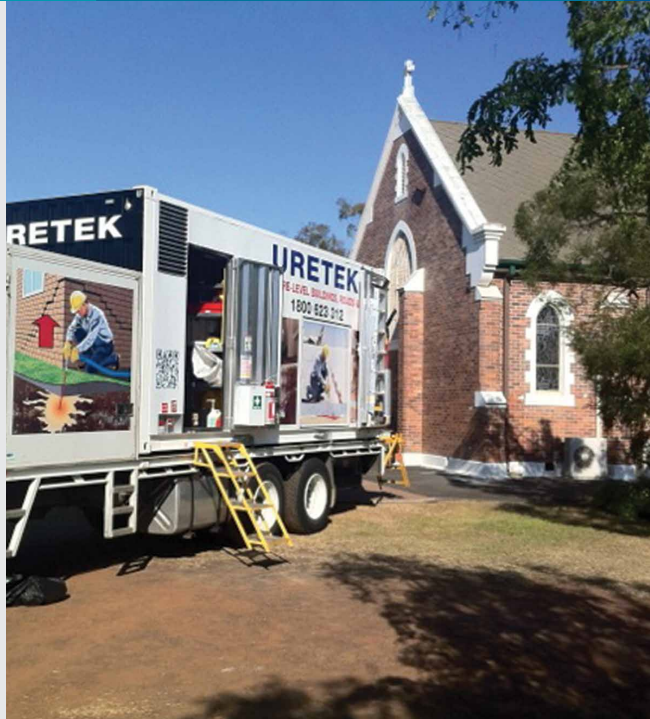
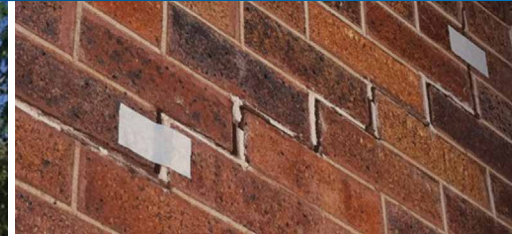
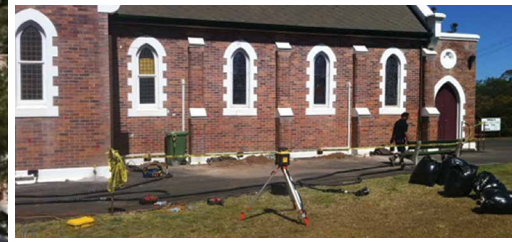
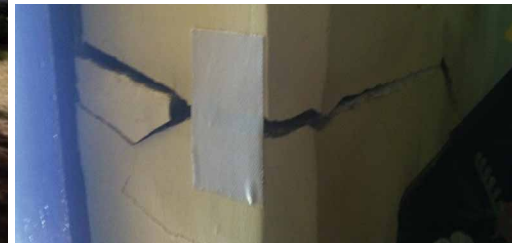
An underground aquifer caused the emergence of large cracks throughout the 89-year-old St John's Anglican Church in the south-east Queensland town of Dalby.

The cracks visible inside the Church appeared following the summer floods, despite no water flooding through the building. A possible cause was the rise in the aquifer, which dates back to the 1800s, moving the Church's foundations.

The restoration of the church to its original levels was an outstanding success, as cracks were closed up on both the exterior and interior walls of the Church and the floors were re-levelled.

The work was done so carefully that none of the beautiful stained glass windows was broken or cracked.
