# Heritage Building Re-levelled

Earthquake remediation

Kaiapoi, New Zealand

Mainmark New Zealand

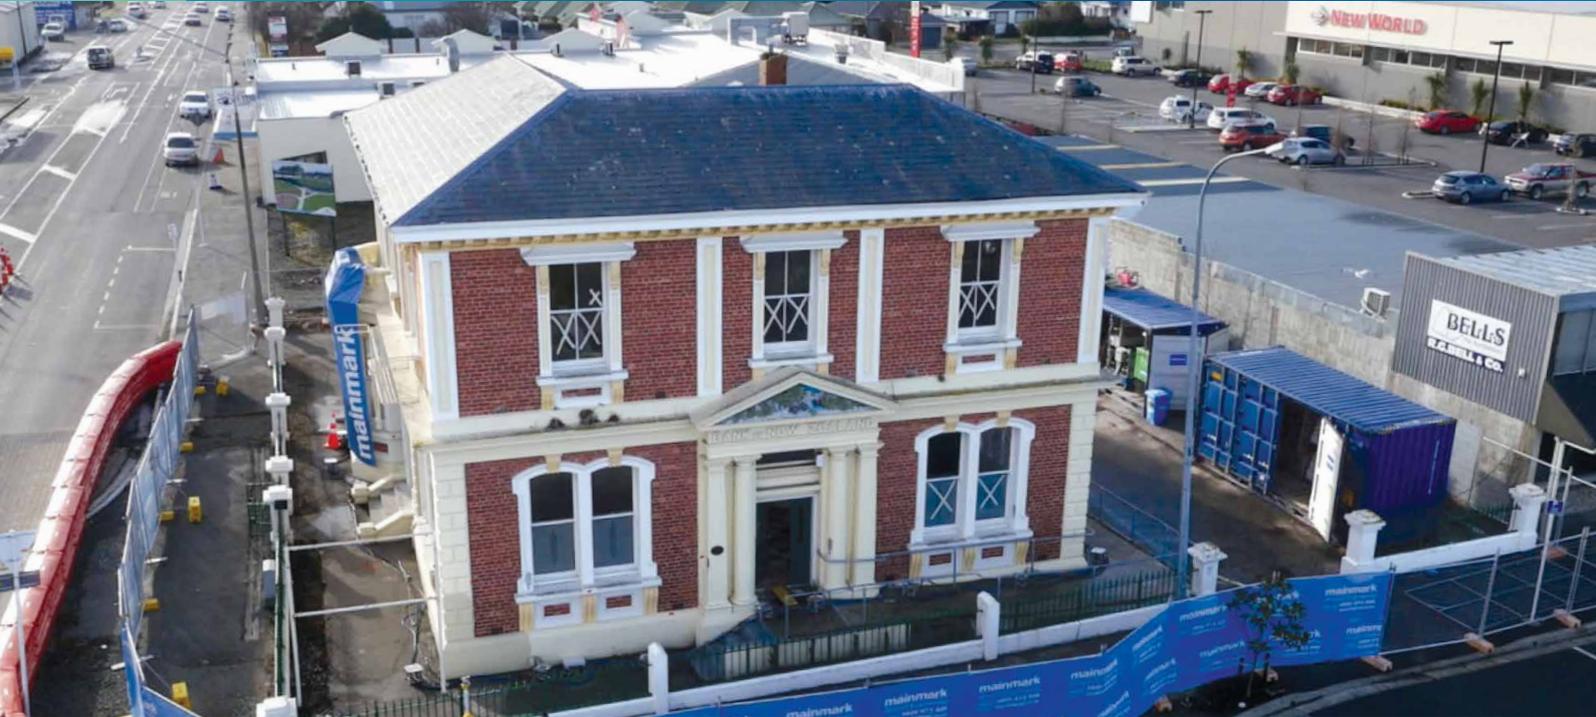
Above: Earthquakes resulted in substantial damage to this Category One Heritage listed building in Kaiapoi, New Zealand.

The 250-tonne building had subsided across the entire footprint towards the North East corner by more than 200mm.

JOG computer-controlled grouting was used on the project. JOG is a non-invasive method, delivering a highly controlled, precise and gentle lift.

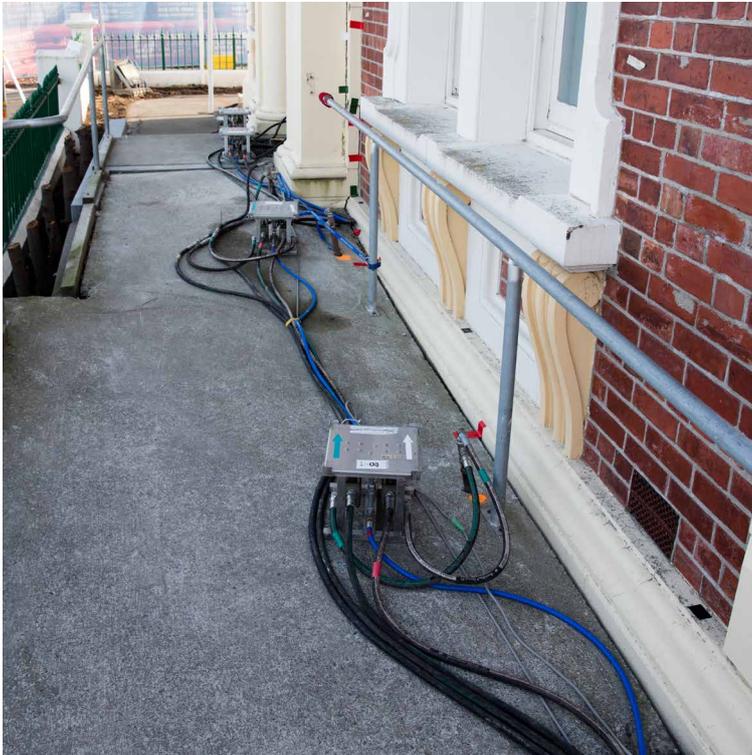
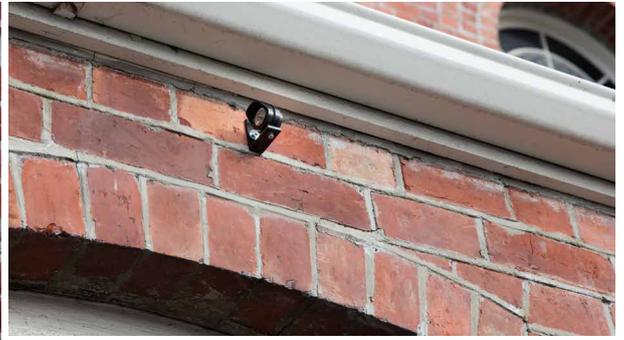
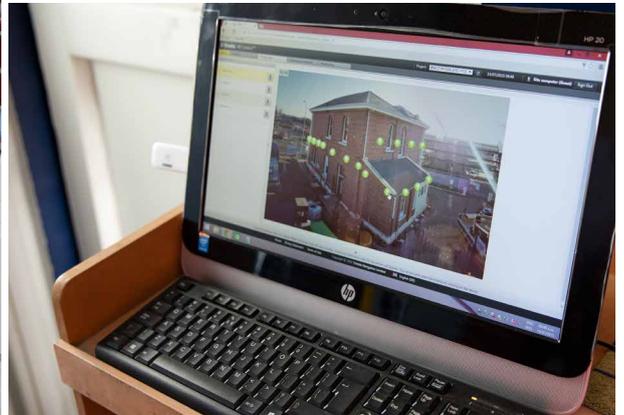
Above: JOG androids were placed at pre-determined, strategic points, internally and externally. Use of this non-invasive technology meant any further, significant damage to the heritage building was avoided.

The building's construction, current condition and the degree of lift required were all considerations in the design of the injection array. One hundred 40mm diameter injectors were installed beneath the perimeter and internal foundations of the building, including the existing bank safe. There was minimal impact to the historic floors, which meant they did not need to be removed.

Lifting was gentle, uniform and gradual, protecting the fragile nature of the building. Continuous surveying, internally and externally, was delivered via a fully automated Trimble monitoring system and manual assessment. The high degree of monitoring was a key contributor in achieving such an accurate and precise outcome.
