Harbour Seawall Rehabilitated

Seawall

Void Filling and Sealing

Sydney, Australia

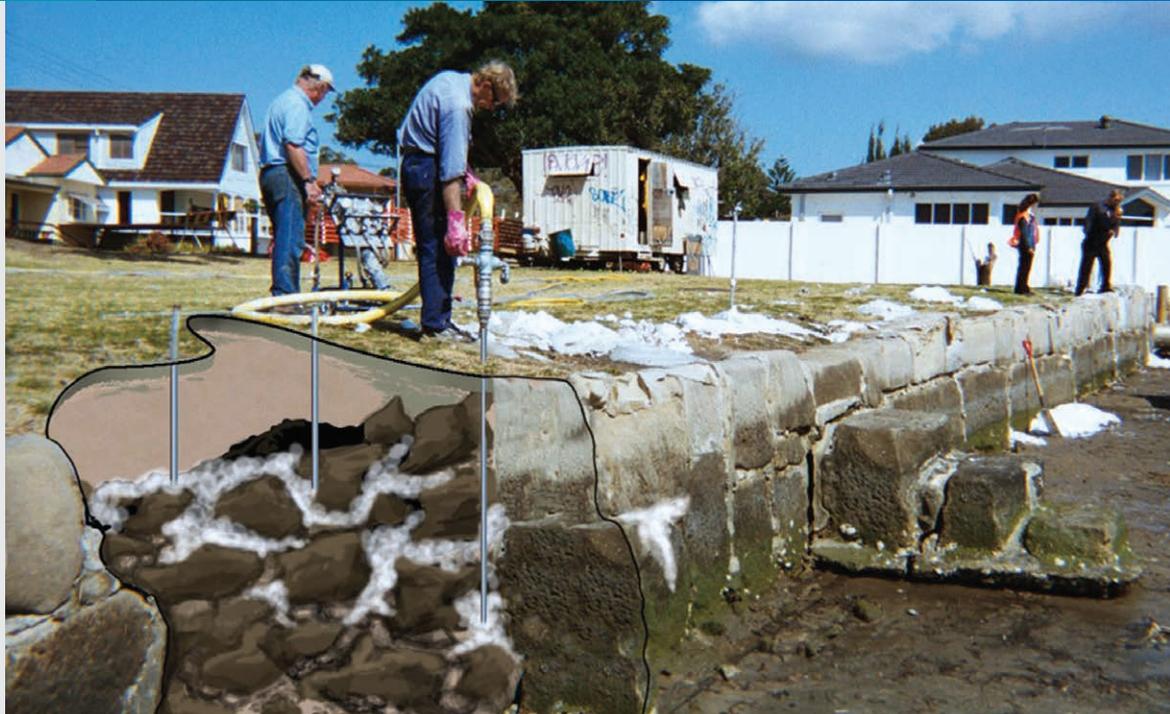
Cut-away demonstrates the void-filling action of Benefil.

After testing to determine the degree of voiding of the subgrade behind the wall, injection pipes were installed in a grid pattern to varying depths across the whole area.

Through the 40mm Ø pipes, Benefil amino-plastic resin was injected by hydraulic pressure. Injection was continued until the resin emerged from the joints right across the wall face.

This indicated that all voids, including crevices and cracks had been filled. Subsequent probing confirmed that no voids remained in the areas behind the wall.
