# Tank Sealing and Void Filling

- INDUSTRY**  
Infrastructure
- STRUCTURE**  
Tank
- PROBLEM**  
Holes and Voids
- LOCATION**  
Cairns, Australia
- DURATION / YEAR**  
4 days / 2014
- TECHNOLOGY**  
Mainmark Civil & Mining  
Void Fill and Water Stop
- BUSINESS UNIT**  
Mainmark Civil & Mining

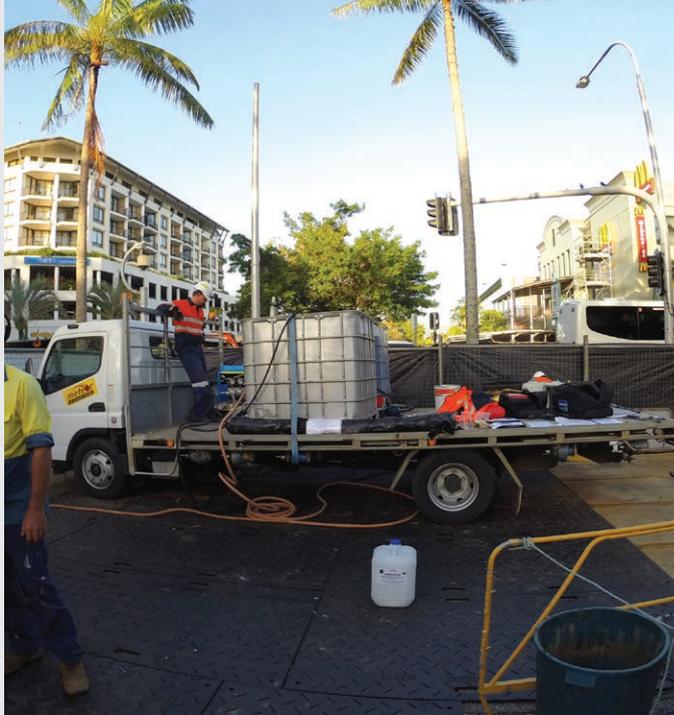
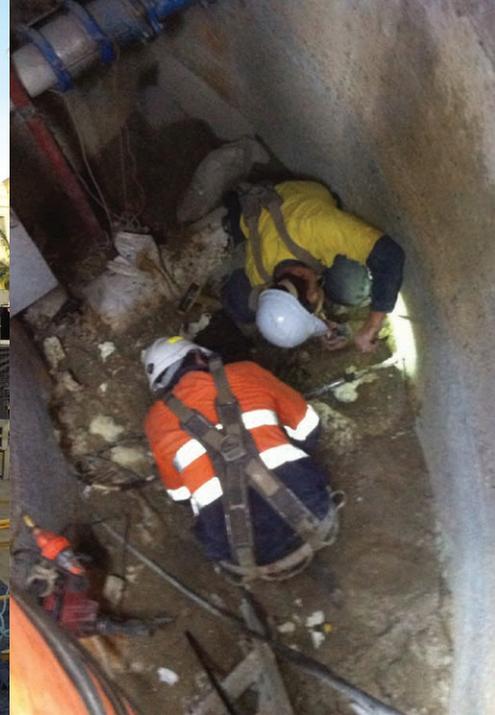
An underground tank located in the heavily trafficked area of the Cairns waterfront precinct was to be converted into a refurbished shallow junction pit for the transfer of waste water and effluent. The concrete tank was surrounded by ground water to a level of only one metre below street level and had to be sealed to prevent water ingress. The new piping junction was installed and then the tank was filled with expanding resin to ensure the safety of pedestrians and vehicular traffic.

In the first instance MCM applied a quick reacting two-part polyurethane resin that would react in the presence of high volumes of water. This sealed the underground external area of the tank where the

penetrations were to be installed for the incoming new sewer pipes. It ensured that the ground water was blocked from entry during the cutting of the penetrations and installation of the incoming pipes.

Later, following the installation of the pipes, MCM returned to the site and filled the void of the tank with another fast set expanding urea silicate that was impervious to ground water. This ensured that support was provided and that, should anyone be able to access the tank, there was a solid barrier to eliminate the risk of actual entry into the tank.

The tank was successfully modified by the client's sewer contractor and the new pipes installed and the junction completed. The void was filled to maximum capacity of 120m<sup>3</sup> and then sealed from entry. Following clean-up, the area was returned to the city and opened for public traffic use again. MCM works were completed in a total of four days with minimal impact on the aesthetics or traffic flow of the area.
