Airport Drainage Channel Re-levelled

PROBLEM
Sinking pavement

LOCATION
Nagoya, Japan

TECHNOLOGY
Uretek Slab Lifting

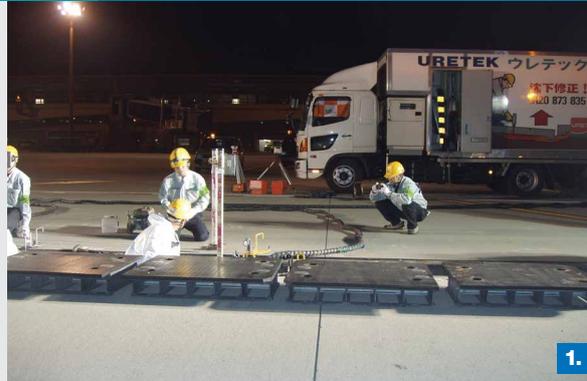
Pictured above: 1. Mats and grills removed as injection was carried out. 2. Mats removed showing grills in foreground. 3. Channel sunk 40mm. 4. Exact designed level re-established. 5. Airport operations continued uninterrupted.

The injection was carried out with extreme precision to achieve the exact levels required with the aid of continual laser level monitoring.

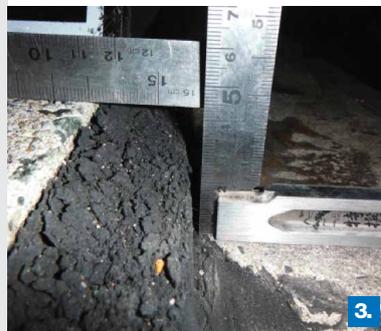
The major drainage channel on the taxiways of Nagoya Airport had sunk, due to sub-base saturation, causing aircraft to become detached from the tug vehicles towing them. The channel was sinking more day by day.
