Airliner Wash-down Area Re-supported

Sinking taxiway

NSW, Australia

Uretek Slab Lifting

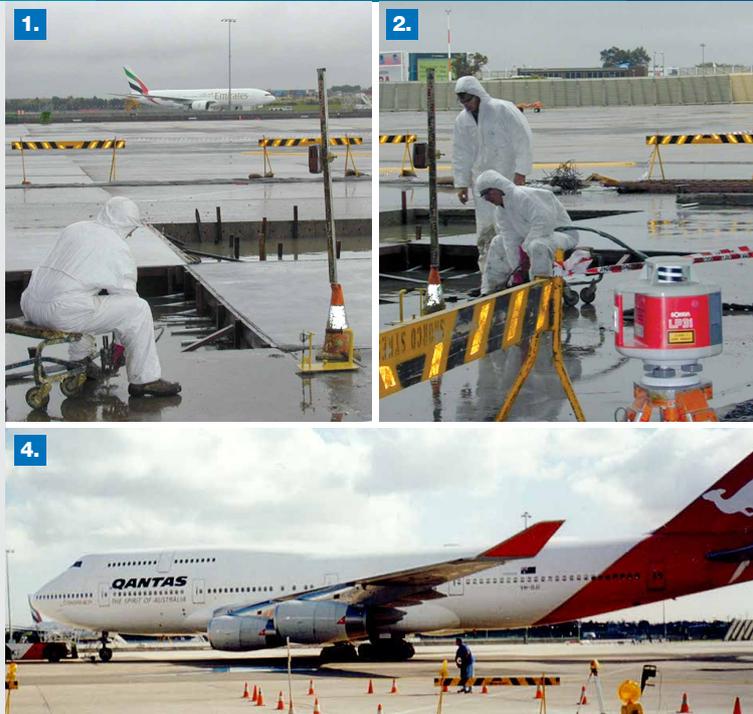
Constantly saturated, the wash bay slabs had been undermined and lost support due to the sub-base

losing fines with the hydraulic pumping action of the aircraft moving onto the area.

Where jacks had been used under the planes some slabs had even cracked so badly that they had been removed for replacement as shown in the photographs.

Pictured above: 1, 2. Technicians watch dial gauges (yellow) and the laser level (on the staff) as they raise the slabs to the precise required levels. 3. Extremely thick, the slabs were keyed in one direction and dowelled in the other. 4. 747s were able to use the area just 30 minutes after completion.

The technology applied was our patented method, Uretek Slab-Lifting, with expanding structural resins being injected below these very thick slabs to fill any voids, compact the sub-base and raise the slabs back to their precise design levels.
