# Rock Weir Consolidation

Weir

Void filling & sealing

NSW, Australia

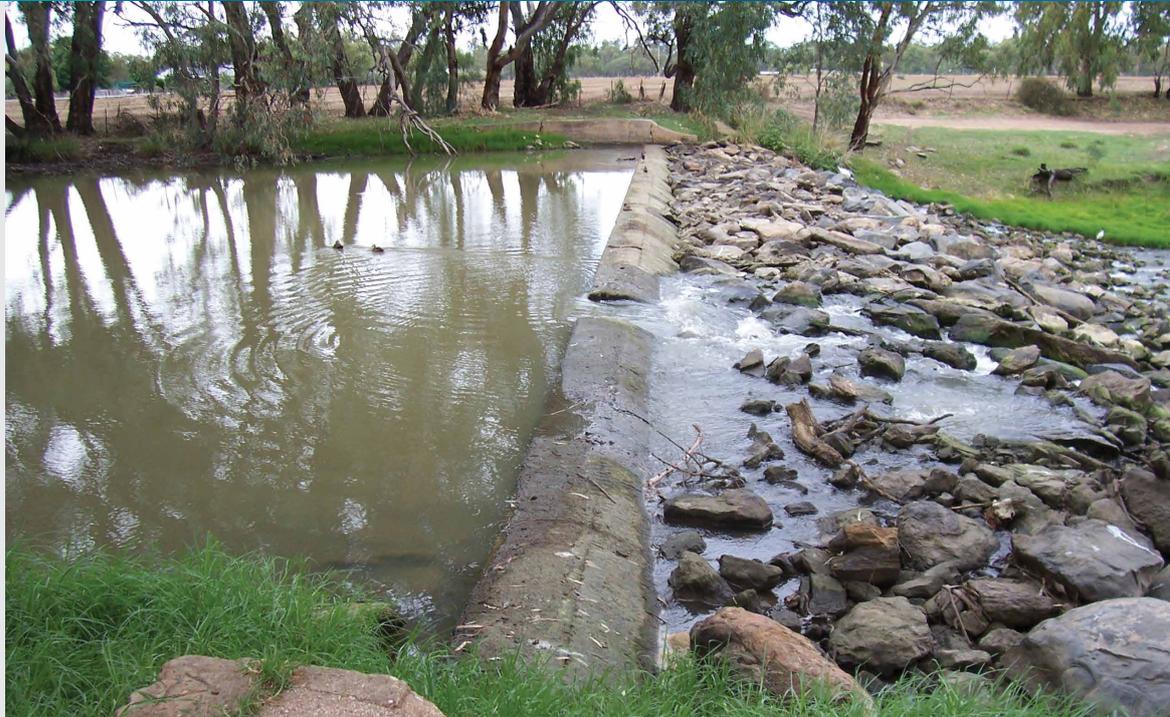
The issue confronting the Council engineers was that the weir had exceeded its original design life, and consequently the concrete and timber-plank-faced dam wall below the water level was failing. This was allowing the water to penetrate the wall and threatened to wash away the supporting rock retaining structure, resulting in total weir failure.

The weir was estimated to be losing water volume far in excess of design flow, 25 megalitres (equivalent to 25 Olympic swimming pools) daily.

For this project, an environmentally inert, engineered structural resin was selected. The grout was injected from above, under difficult conditions, into the body of the supporting rock retaining structure, behind the dam face.

The grout successfully filled and sealed the breaches in the dam structure, stopping the flow of water below the waterline. Injection was then repeated into the adjacent supporting rock structure, a metre or two downstream of the dam wall.

The engineered structural resins consolidated and strengthened the wall and rock structure into a single and impervious mass.
