Marina Ship-lift Slab Area Re-habilitated

Sinking Hardstand

Mackay, Queensland,
Australia

Uretek Slab Lifting and
Uretek Deep Injection

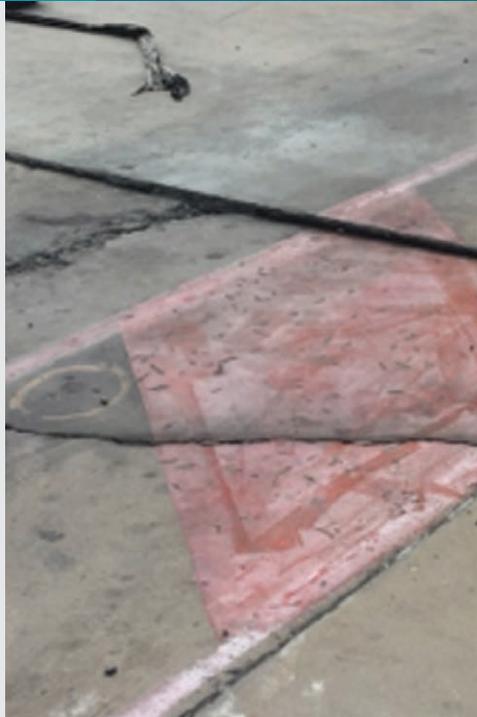
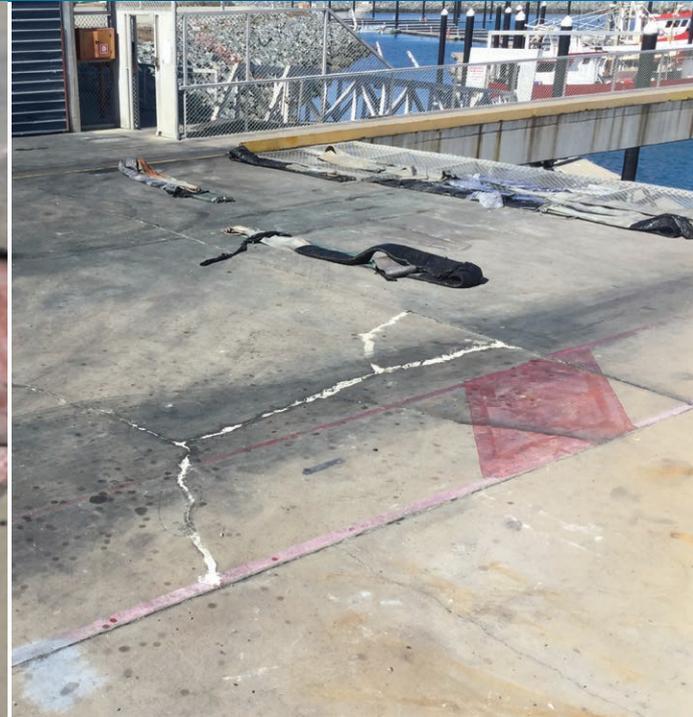
Right: Before.
Far right: After.

The ship-lifter slab area of the marina in Mackay, Queensland, had sustained major cracking, which damaged the integrity of the slab and jeopardised the operations of the marina business.

The cracking in the concrete had been caused by the loss of support immediately beneath the paving, all the way to the seabed. This loss of support was attributed to the migration of fine particles due to the ebb and flow of tidal action in the marina.

injections to re-support and re-level the slabs. The area was re-levelled by Uretek Slab-Lifting applied directly under the slabs. The foundation ground was compacted and greatly strengthened by Deep-Injection of Uretek resins to a depth of 3m.

Continued injection immediately under the slabs across the whole area raised them to the required levels and ensured an even displacement of the loads across the entire slab area.

Following this treatment, the slab cracking was stitched with an epoxy repair compound and locked together with tie-rods.

The slab was re-supported and raised to within 5mm of its design specifications and the area was trafficable within 30 minutes of completion of the project.
