Domestic Pool and Surrounds Re-levelled

Uretek Deep Injection &
Uretek Slab Lifting

Mainmark Australia

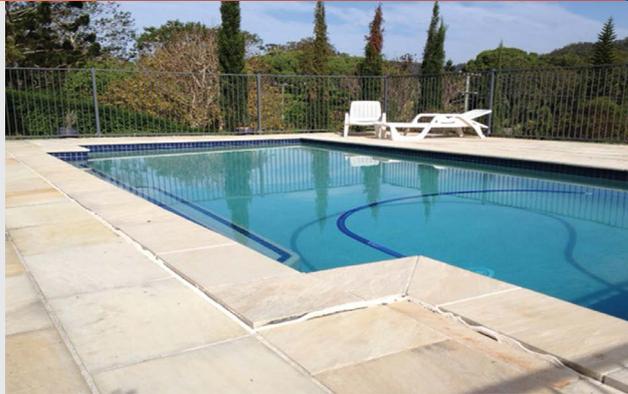
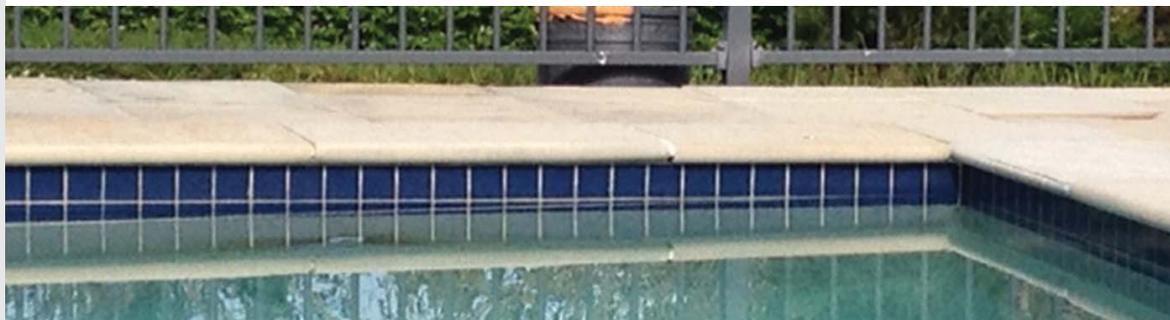
A large pool at a home in Southern Queensland had sunk 90mm into the ground at one end. The pool had been built on filled ground but had no allowance for concrete piers to support the pool over the fill. Over time it had subsided.

Above, left and below: the water level shows how far one end of the pool structure had subsided. Above, right: Technician watches the dial gauge (yellow) as he raises the surrounds to the level of the pool edge.

Expanding structural resins were injected into the uncompacted fill under this pool. That compressed the soil, greatly increasing its bearing capacity. Further

injections under raised the pool a millimeter at a time until it was exactly level again.

The pool was raised exactly the 90mm to level. The project did take only two days and came in on quote. Both the Pool Association and the homeowners were so impressed that they have recommended us to other pool owners.
