Restoring Culverts In A Rainforest Area

Culvert

Void filling & sealing

North Queensland, Australia

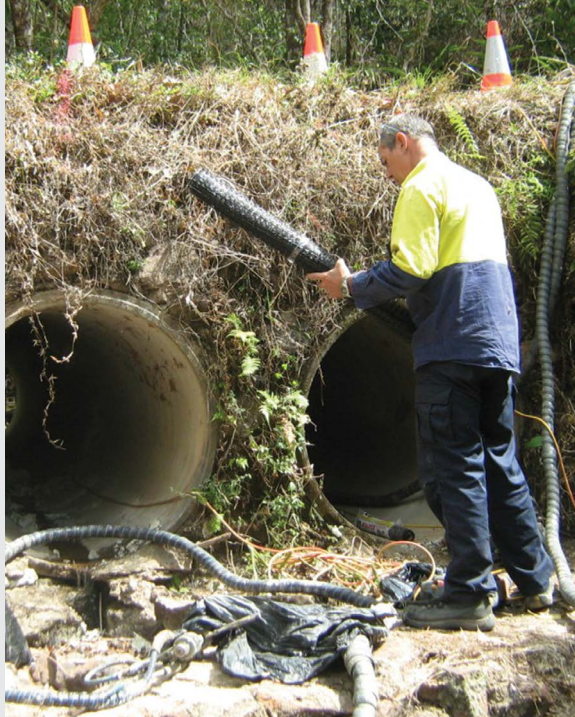
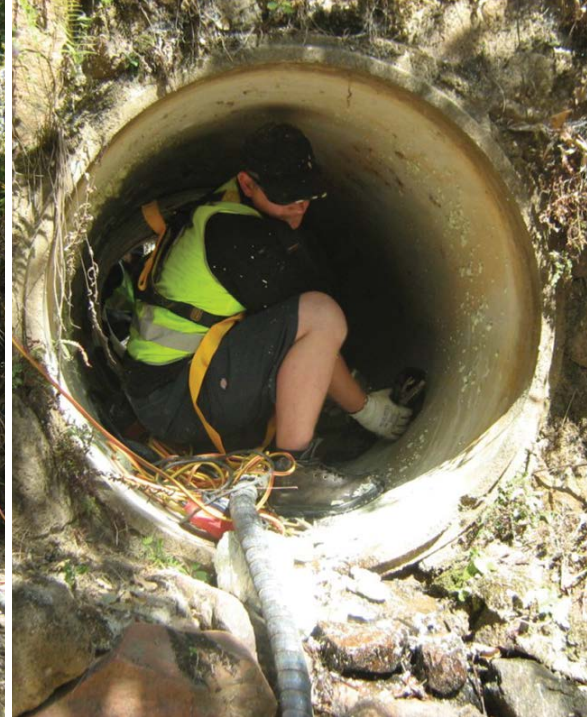
Pictured above: Culverts, 70 metre long, in a North Queensland rainforest were re-aligned and re-supported; and the roadway above was also re-supported, all in just two days.

Working from the inside of the slippery, wet pipes, our team correctly re-aligned the culverts, sealed the joints and filled 10m³ of voids.

The culverts were re-aligned and re-supported. The roadway was re-supported. No material escaped into the environment.
