Large Swimming Pool Re-levelled

Sinking pool

QLD, Australia

Uretek Deep Injection & Uretek Slab Lifting

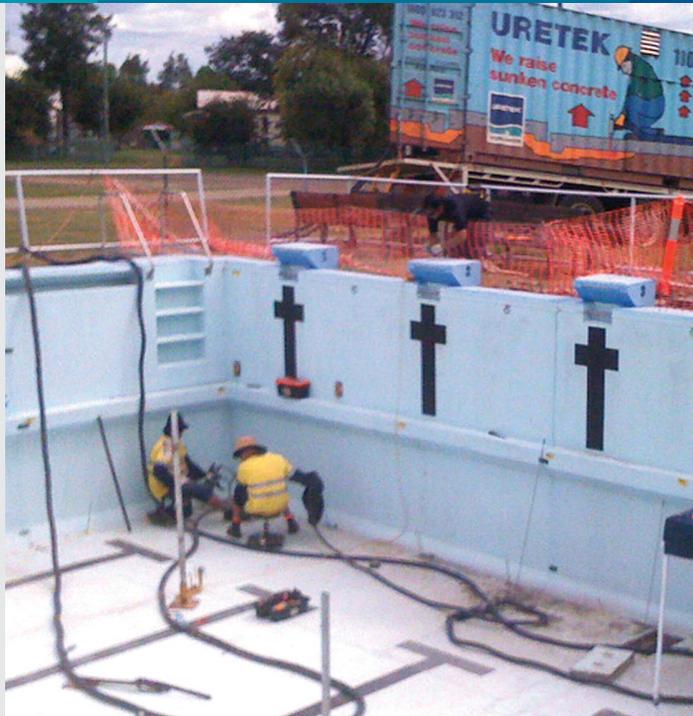
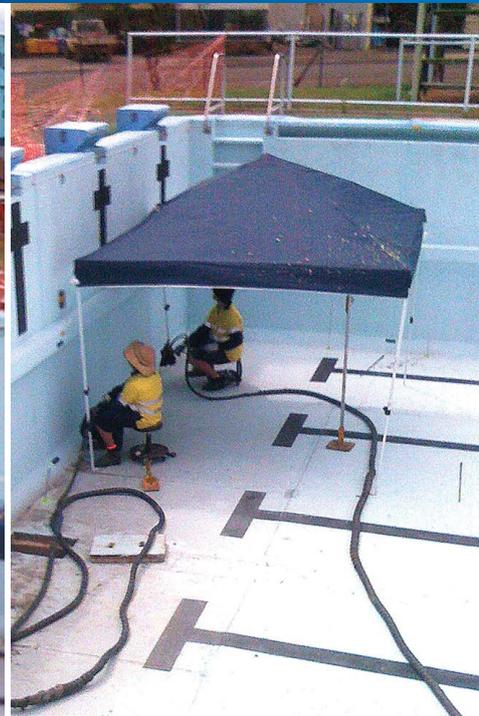
The 25m long public swimming pool at Monto, two hours west of Bundaberg, Queensland had sunk into the ground by up to 200mm toward the deep end.

The pool had been built in sections of precast concrete. Using a carefully sequenced program of expanding resin injections into the foundation ground under the pool the team brought the complex pool structure right back to level without mishap.

We were commissioned to lift the pool back to level. The pool had been built in precast concrete sections. The walls were precast with flat bases and concrete infill precast sections formed the floor of the pool.

The floor joints were set down with mastic filler and vertical joints were mastic filled. The fact that the sections were pre-cast dictated a need for extremely precise and careful lifting. Over-lifting any one section could break the joint. Also, due to its large precast base, the wall could easily rotate inwards or outwards.

Additionally, as the floor slab was sitting on a step joint, the internal slab could not be lifted as this could have caused this slab to lift at the joint. This meant a slow process of lifting each precast wall section a small amount at a time to slowly bring the pool back to an acceptable level.

Then the correction of levels was proved by pouring water in the gutter. The water in the gutter flowed to the shallow end again. Then the voids under the internal pool slab were filled very slowly with great care.
