Integrity Of Heritage Sea Wall Restored

Seawall

Void filling and sealing

Victoria, Australia

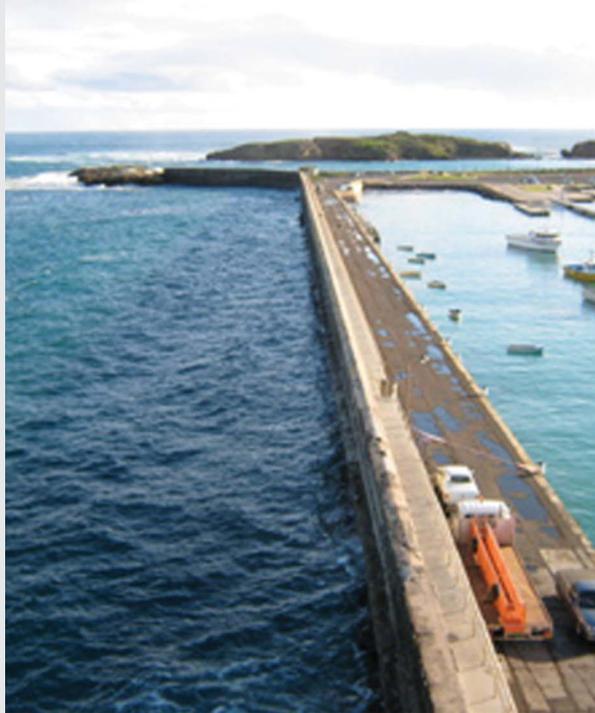
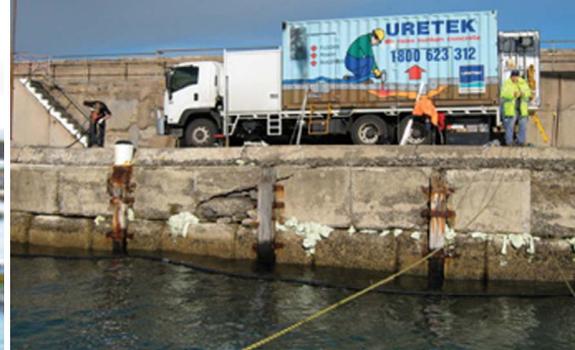
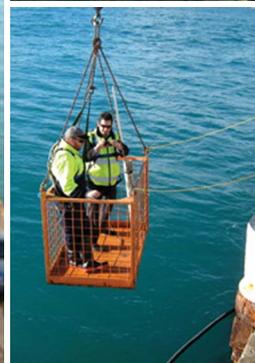
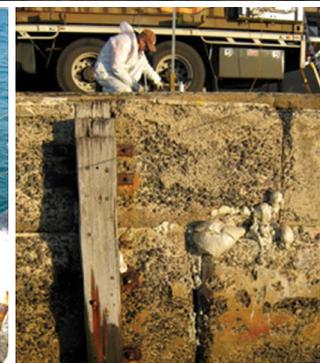
On the notorious “shipwreck coast” in Southwest Victoria, Australia, the heritage-listed Warrnambool Sea Wall, built by hand in 1880 takes the full force of the Great Southern Ocean. Over the years, the water action undermined the structure of the wall and eroded the concrete blocks, allowing large volumes of water to travel right through the wall body and exit out on the harbour side of the wall.

Above: The sea wall built by hand in 1880 was eroded by the force of the ocean and needed a great deal of sealing by Uretek Deep Injection.

This was a difficult and challenging job, and eventually it was decided to deliver the material through the back of the first row of blocks and drill through the top block to locate the voids.

Drilling was tough going and very abrasive on the drill bits, due to the blue ballast rock, and the presence of an old railway line running through the site, but eventually the Operations Crew succeeded in detecting and filling all the significant voids.

The sea wall works to prevent further erosions were successful and any excess cured material liberated during injection was easily contained by the use of a floating boom, and recovered from the ocean.
