# Cold Storage Facility Re-levelled by JOG

Freezers store

Earthquake remediation

Christchurch, New Zealand

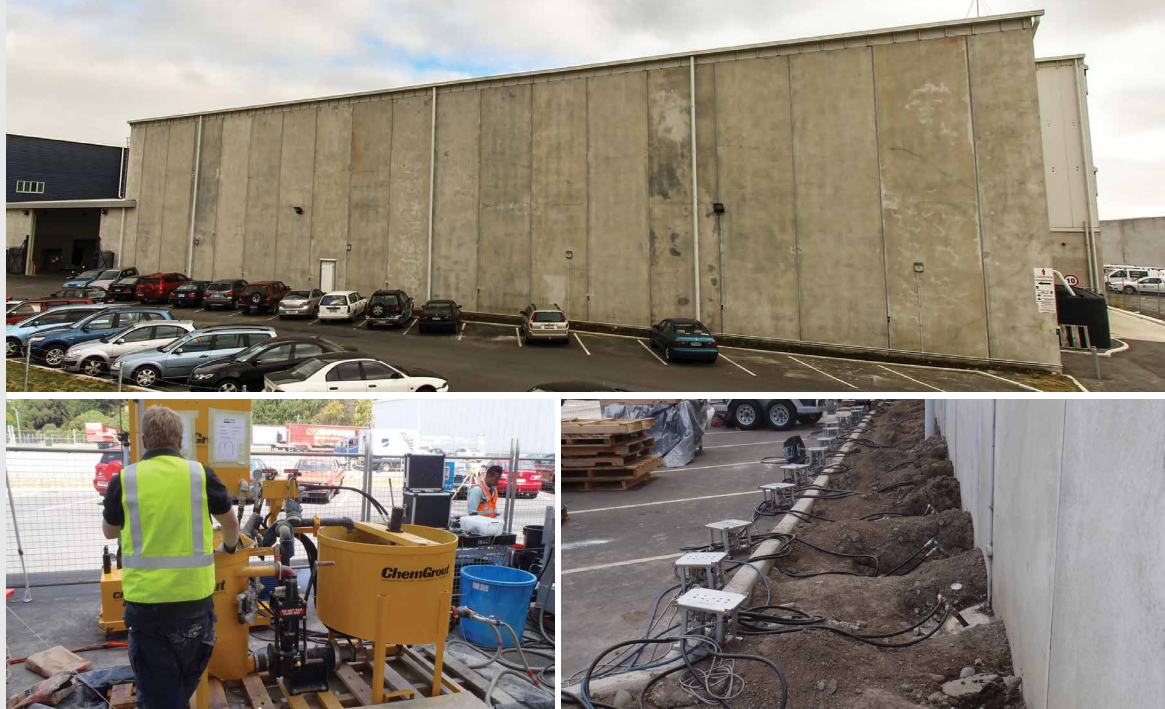
Above, top: The freezer building which bore very heavy storage loads. Above, left: The grout batching centre. Above, right: A section of the JOG injection array along the principal area to be rectified.

A continuous JOG circuit of 36 primary injection ports was installed along 56 lineal metres of 11m high wall. We then proceeded with a sustained sequence of injections of JOG cementitious grout.

Continuously monitored and computer controlled, the lifting of the very heavy structure was uniform and gentle. This process raised the side of the building as much as 57mm, bringing the area to the required level.
