Art Gallery Re-supported and Re-levelled

Art Gallery

Earthquake remediation

Jet Grouting and
JOG Computer
Controlled Grouting

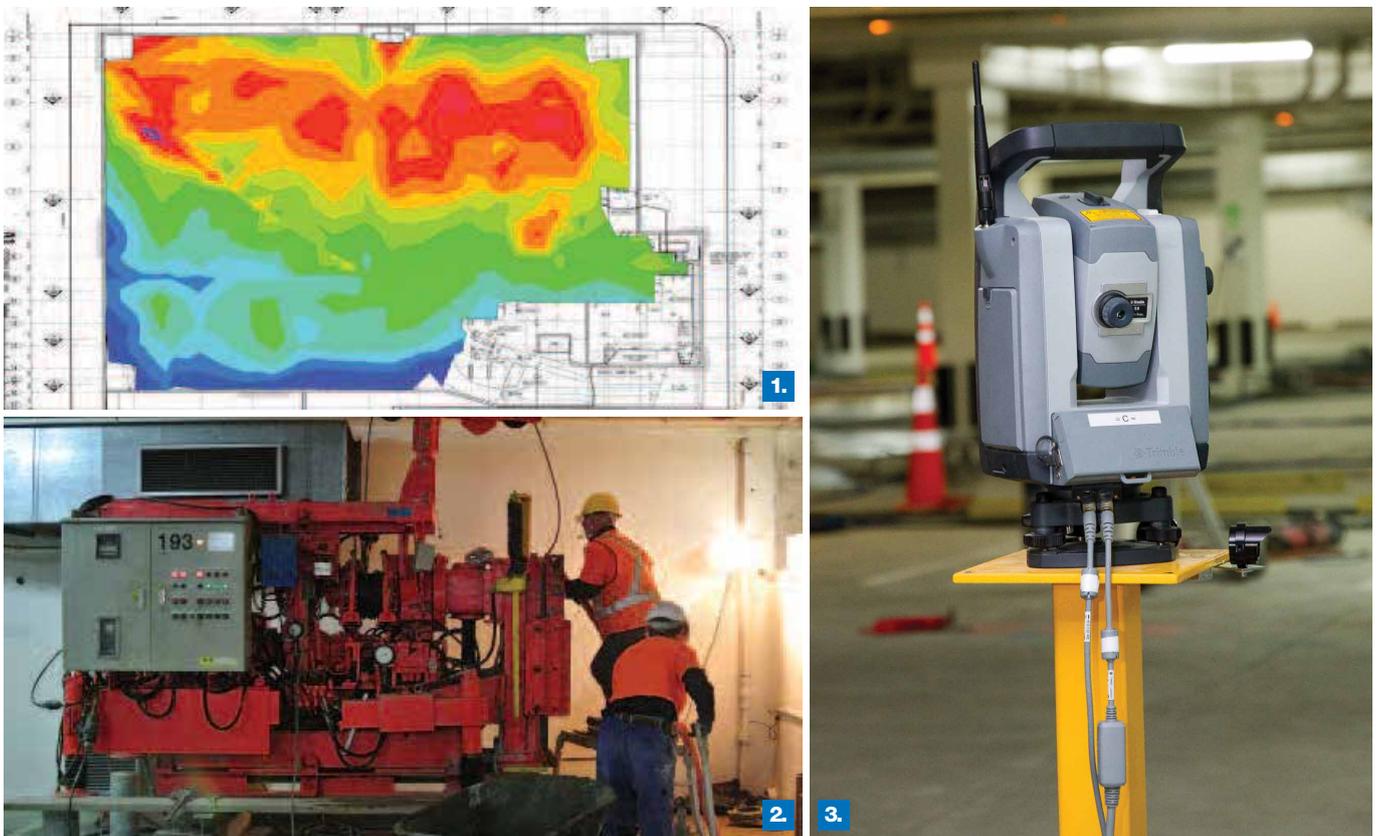
Pictured above: 1. Example of the continuous scanning of levels. The colours change constantly showing the progress of levelling in each area. 2. Our technicians operating a jet grout injection machine. Note the low head-room. Our smaller machines can create large soil-crete columns from much smaller rooms. 3. Our JOG computer-controlled levelling is monitored by sensors throughout the basement.

Mainmark team, working with the Council's engineers and Aurecon engineers, employed Trimble billion-point plotting of positions and levels. Comprehensive 3D computer models of the building were produced, showing every miniature part of the structure and its position laterally and vertically.

The Mainmark team also set up an automated robotic station-based wireless survey system to monitor levels, that enabled access to data from the many points across the entire building, in real time.

Installation of 124 jet grout columns under the critical load points of the building to strengthen the foundation ground for better support of the entire structure. These columns are sometimes referred to as "soil-crete", being a mix of in-situ soil and cementitious grout.

The soil-crete columns were made to 3m and 4m Ø and to a depth of 6.5m. These columns were created through penetrations of just 200mm.

Then the JOG method was used to re-level the settlement. For this, 350 ports were installed, via 40mm penetrations, for injection of cementitious grout to immediately beneath the huge concrete footings.

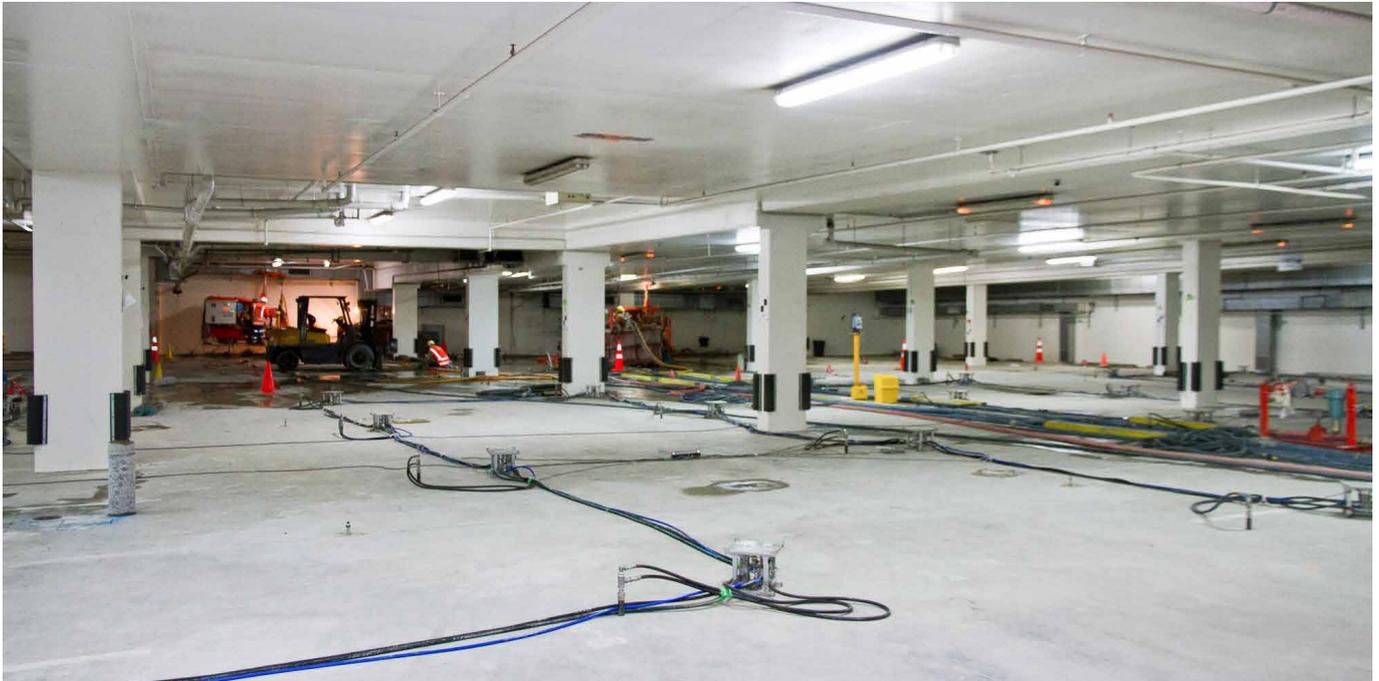
Above: Our JOG computer-controlled levelling team hard at work. The automated, neat, clean and quiet scene with progress of levelling monitored by sensors throughout the basement and observed in real time by our control room staff.

Lifts of up to 182mm were required in some areas. The average amount of lift achieved was 2mm a day. The average amount of material injected was 34,000 litres. This peaked one day at 71,000 litres.

In total the JOG work used nearly 1.5 million litres of injected material requiring over 16,000 x 25 kg bags of cement. The JOG work took 44 days and there were 22 men working on an average day.

The foundation ground of the structure was strengthened and the design levels were restored to +/- 10mm in every location across the entire 6,500m².
