Shopping & Office Complex Re-levelled

Earthquake remediation

Christchurch, New Zealand

Mainmark New Zealand

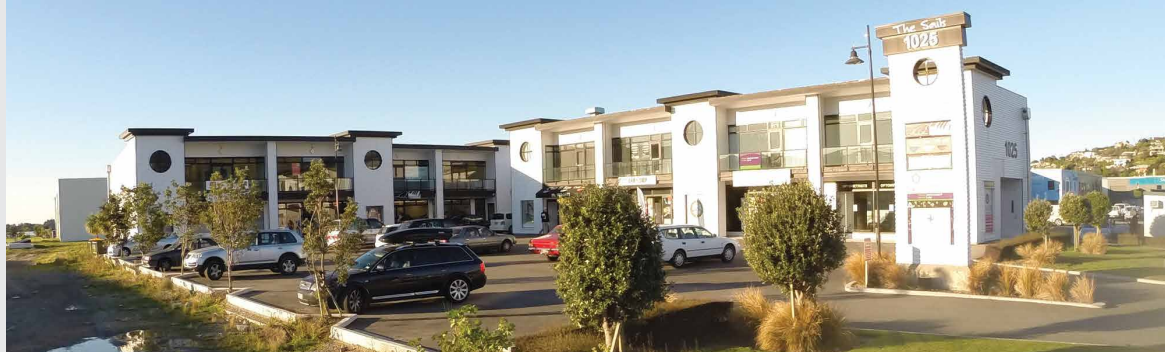
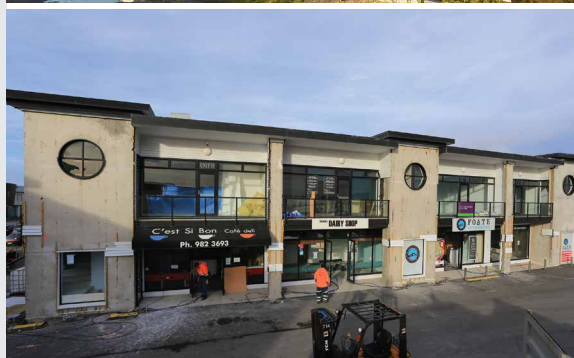
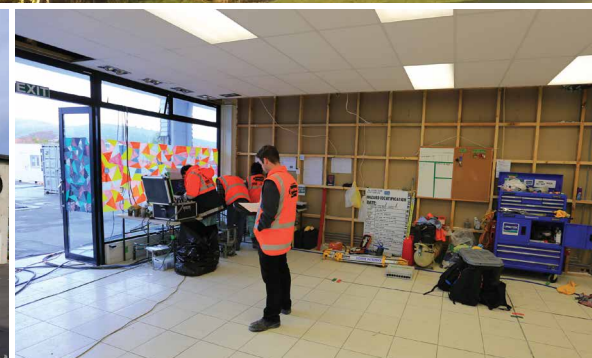
Due to seismic events, this pair of buildings, that make up a small shopping and office complex, had each subsided, tilting backwards quite markedly.

The rear of the building pictured on the left subsided and tilted 153mm, and the one on the right sunk 67mm, in the earthquakes of 2010-2011.

The building structures themselves were not substantially damaged but the subsidence was reasonably severe.

Mainmark rectified the settlement, with JOG integrated computer grouting, lifting the load-bearing elements, with Uretek expanding resin injection raising and undersealing the floor slabs

84 JOG injection ports were installed to inject beneath the load-bearing elements of both buildings.

Different injectors were also installed to raise the non-load-bearing floor slabs by means of Uretek expanding resin injection.

The two injection processes were applied at the same time, beneath both buildings. This way the entire complex was brought up, very gradually, and without placing any uneven stress on the structures.

The combined JOG and Uretek processes were successful in raising and re-levelling the entire building complex.
