Rehabilitation of Stormwater Chamber

Stormwater pit and embankment

Ageing infrastructure and subsidence

Bronte, NSW, Australia

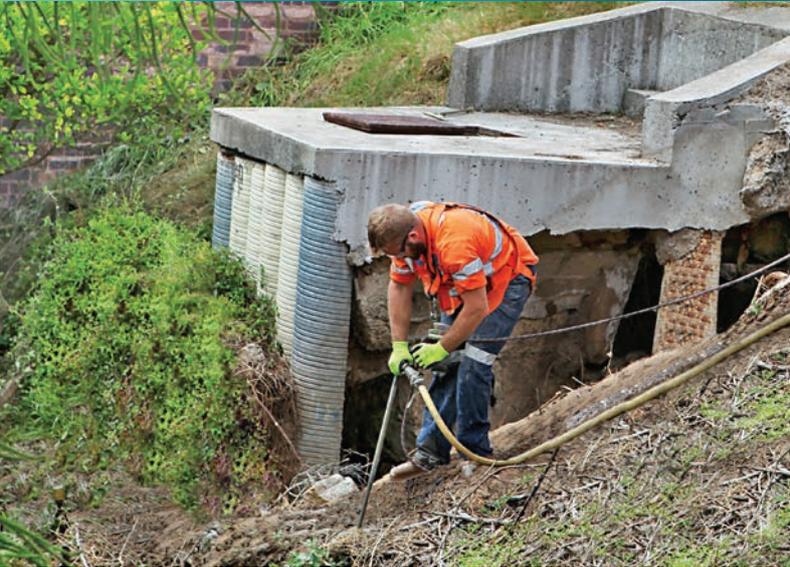
Left: Injection lance flushed into the ground, strengthening the sandy embankment with Permeation Grouting
Right: Technician coating inside of the stormwater chamber with ENCAP6™

First, the Mainmark team used Permeation Grouting to stabilise and strengthen the sandy embankment surrounding the stormwater chamber. This provided enhanced ground cohesion by producing a solidified mass to support increase loads and fill voids

in the soil. It helped to prevent further erosion and slippage, allowing the area to be safely filled in. This prepared the site for the next phase of the project.
