Retaining Walls Stabilisation

Retaining walls

Sandy soil stabilisation

NSW, Australia

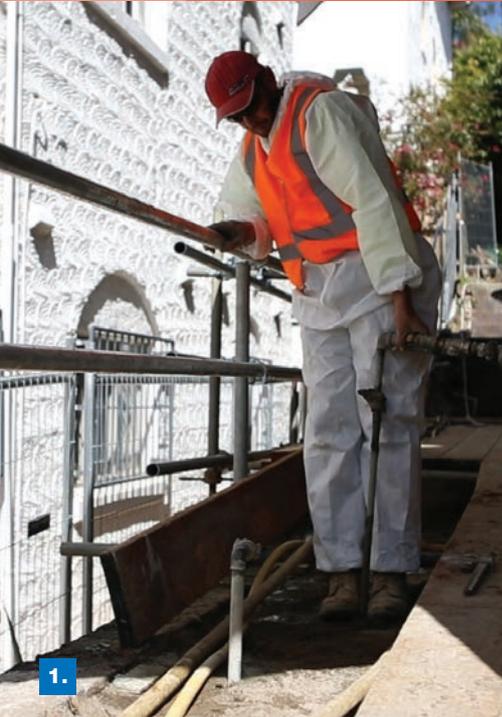
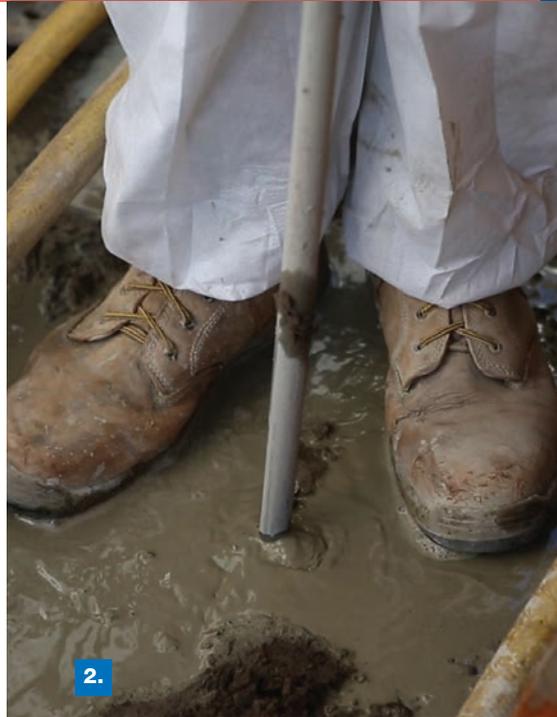
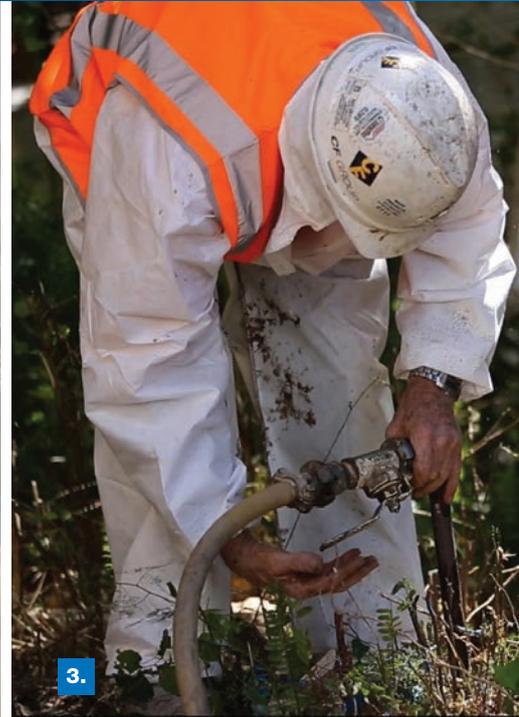
- 1, 2, 3. Injection lances flushed into the ground.
4. Rear garden stabilised and excavated.
5. New retaining wall built.

Microfine cement was grouted into loose sands, providing temporary support to allow excavation for a new retaining wall at the rear of the property and stabilisation of boundary wall.

110 columns were inserted to a depth of 2000mm on the eastern boundary to solidify the loose sands under the footpath and prevent further settlement.

A further 72 columns were inserted to a depth of 4500mm to help retain the mass of loose sand from falling in on the excavation, and 15 additional columns were used to support the north façade.
