Lift shafts stabilised for disabled access to Museum Station

Civil infrastructure (Rail)

Lift shafts

Excavation support

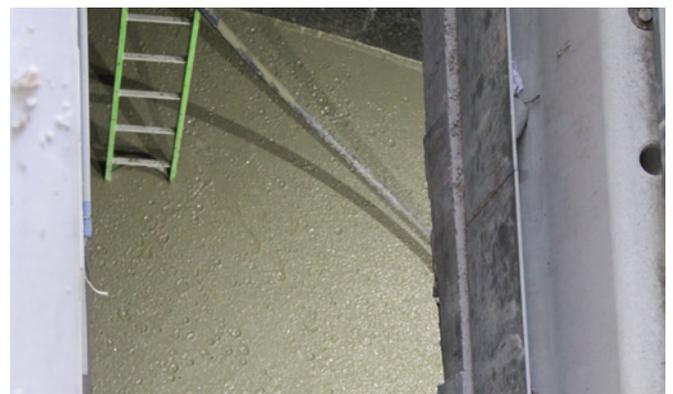
The excavation to be filled extended under Elizabeth Street

The Terefil material was used to fill a large volume, with some spaces up to three metres across. It was highly effective and successful.
