Mine tunnel repair using ENCAP6®

Armco tunnel

Cannington, QLD,
Australia

14 days / November 2016

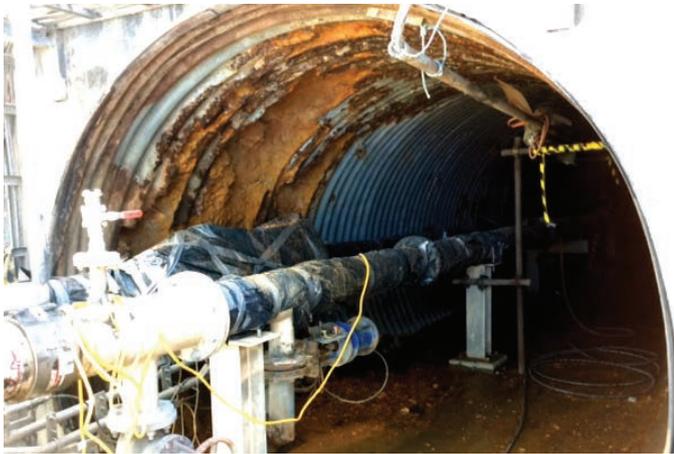
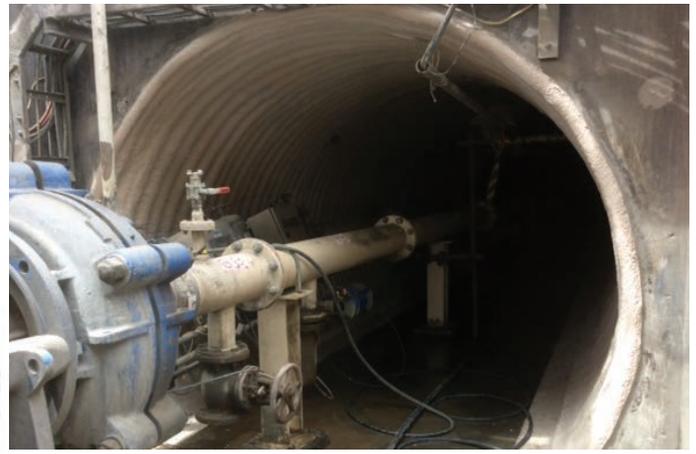
Before and after ENCAP6® application

Mainmark used its technologically advanced ENCAP6® corrosion protection solution to seal, protect and structurally reinforce the tunnel. It offers a longer service life than other polymer systems, especially when in contact with moisture, water or chemicals, making it the ideal choice for the harsh environment of the Cannington silver and lead mine.
