Stabilisation Of Railway Level Crossing

Uretek Slab Lifting &
Uretek Deep Injection

Mainmark Australia

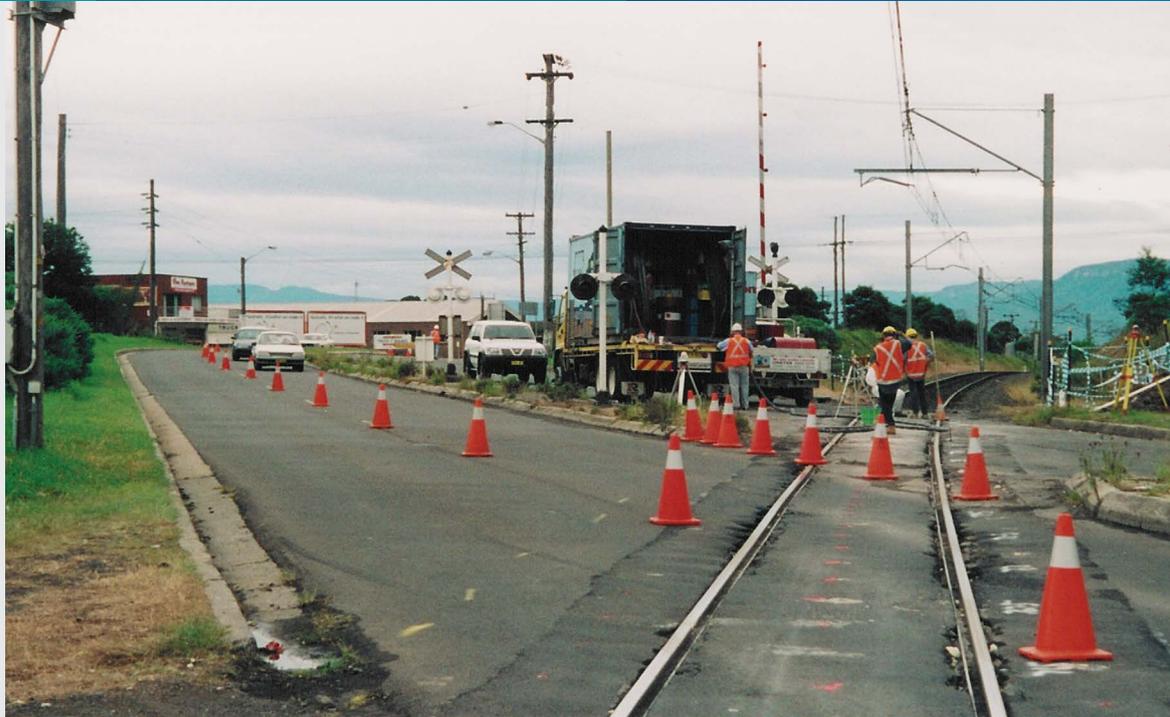
A road and railway level crossing area on the NSW South Coast had subsided and was rocking, not only with the passage of trains, but also with road traffic. Both road and rail traffic had to significantly reduce speed to traverse the crossing safely.

In just two days Mainmark technicians completely re-levelled and stabilised the area with injections of expanding resins into the subgrade beneath the concrete slab that crossed the road and supported the rails.

Working on one side of the road at a time, the Mainmark technicians injected Uretek expanding, engineered structural resins to raise and re-level the slab. These injections were made through the 500mm thick concrete slab at one metre centres along the outside of the rails, and at approximately 500mm centres between the rails.

Once the slab was re-levelled, the subbase was compacted by Uretek Deep-Injection. This was carried out with injections at depths of between 750mm and 1500mm below the surface, strengthening the foundation ground substantially.
