House Re-supported and Re-levelled

House

Weak ground

Uretek Deep Injection &
Uretek Slab Lifting

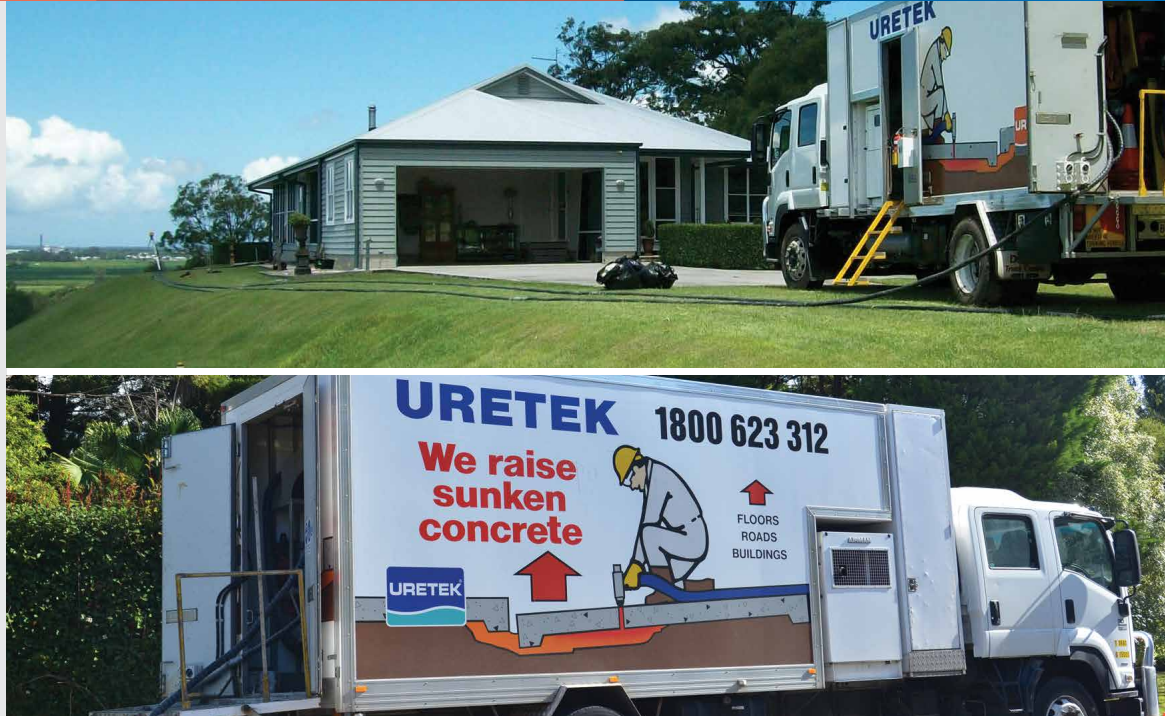
Unprecedented summer rain, of more than 300mm a week, caused extreme saturation of the soil under this large, new Queensland house set on concrete strip footings. The house had subsided by an average 45 mm!

Above, top: This home in the Queensland Gold Coast Hinterland had suffered major subsidence due to exceptionally heavy and sustained rainfall. Above, bottom: Uretek fully self-contained Operations rig.

After an initial drying out period, we injected expanding structural resins into the foundation ground.

Uretek Deep-Injection was used to compact and strengthen the ground. This brought support back onto the sub-base for the dwelling to be lifted and re supported.

Then 42m of strip footings were brought up to correct levels; with an average lift of 45mm being required. This unique method involved no excavation or mess to affect the beautiful home and manicured surroundings.
