Locomotive Wash-down Area Re-aligned

Sinking slab

PT Augusta, Australia

Uretek Deep Injection &
Uretek Slab Lifting

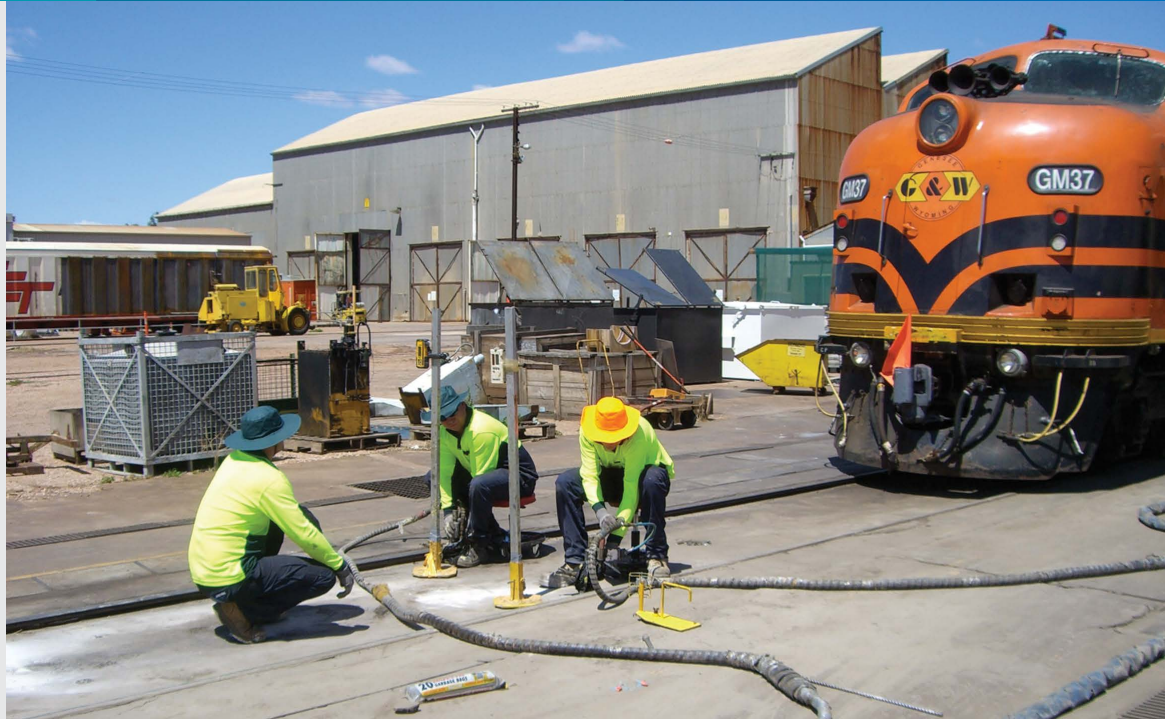
As so often happens with vehicle wash-down areas, a subsidence problem had occurred caused by the ingress of water eroding the sub-base of the slabs. The slabs had subsided preventing the water from running off into the drains between the rails.

Uretek Deep-Injection: We re-supported the area by injecting engineered structural resin directly through the slabs down to the weaker layers to a depth of 1,000 – 1,500mm.

Uretek Slab-Lifting: By injecting directly underneath wooden sleepers and below the ballast, we raised the exact sections of slab required to correct the drainage of the washdown area.

The wash-down slabs were re-supported and raised to correct levels, restoring drainage without disturbing the rail alignment.
