House and Garage Lifted and Re-levelled

Earthquake remediation

Christchurch, New Zealand

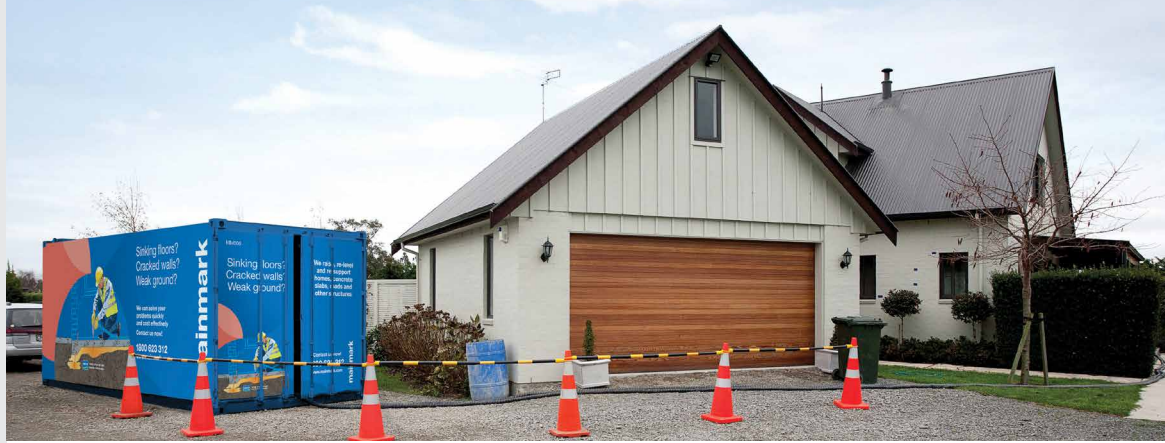
Above, top: Mainmark's small setup footprint for the level correction of a 136m² home and 60m² garage. Above, bottom: With no excavation required, the beautiful gardens were entirely undisturbed.

Uretek Deep-Injection was the appropriate method to provide support under 13 piles supporting the house. Uretek Slab-Lifting was used to re-level various parts of the home and garage. Correction took just eleven days.
