Office Building Floor Raised & Re-levelled

Office building

Earthquake remediation

Christchurch, New Zealand

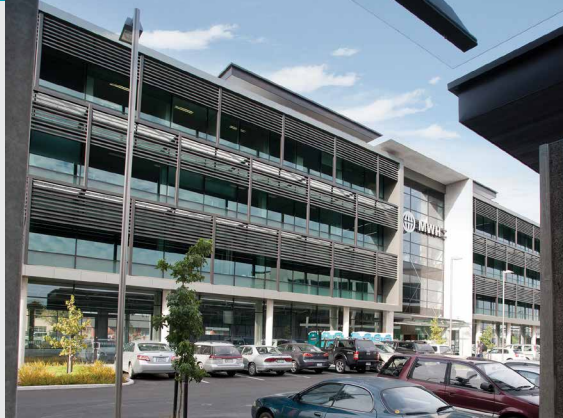
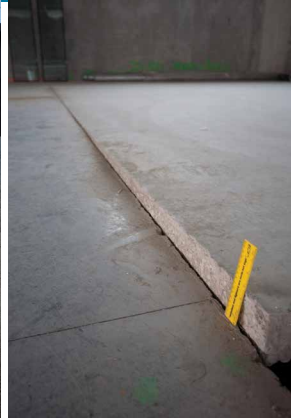
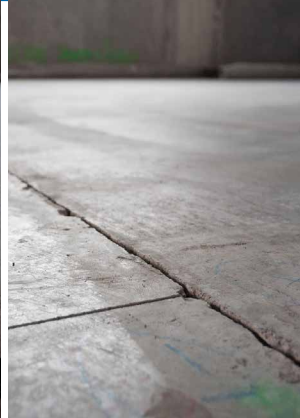
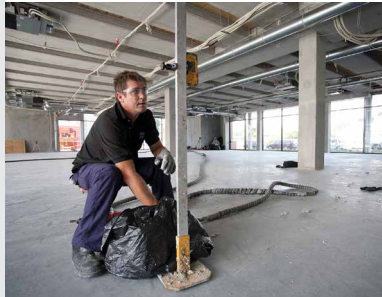
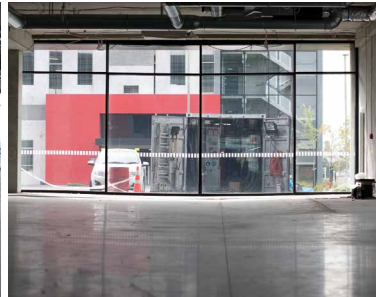
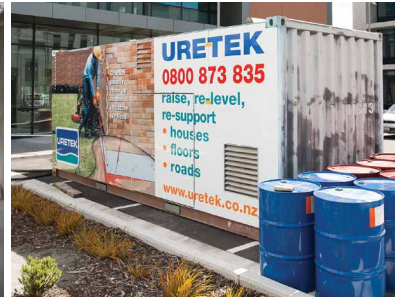
The concrete slab-on-ground floor of this commercial building suffered up to 300mm of subsidence in the Darfield Earthquake. The building was occupied on the upper levels, and remediation works which would not disrupt the occupants were required.

Above: 230m² of the ground floor were re-supported and re-levelled, without any interruption to the business operating on the floors above. Careful injection monitored by laser level ensured precise re-levelling of the badly dished floor dramatically apparent in the centre photo.

Uretek Slab-Lifting method was employed whereby proprietary engineered structural resins were injected under the slab. The Operations Rig could be situated in the building car park without disruption to the occupants working in the commercial offices in the upper floors. Four Operators worked noiselessly over the 7 days to carefully achieve an even fall of the ground floor. Approximately 230m² were treated. Laser level measurements were taken during the works to monitor precise lift and provide reports to the project's consulting engineer.

The ground floor slab was raised and re-levelled to within 5mm tolerances. Clients working within the commercial building experienced no disruption, and the building owner did not have to evacuate the building in order to construct a new ground floor slab which would have been a considerable cost to the client. The Uretek method, therefore, was the most cost-effective and efficient decision for the building owner.
