Pipeline Re-supported and Re-levelled

Pipeline

Earthquake remediation

Christchurch, New Zealand

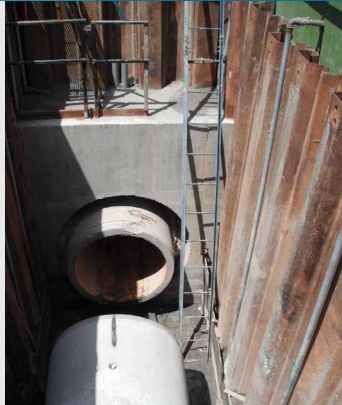
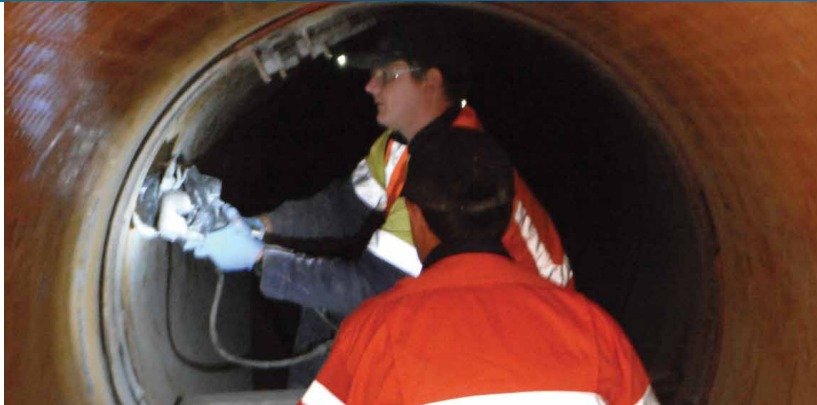
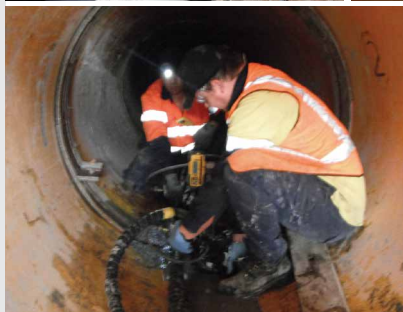
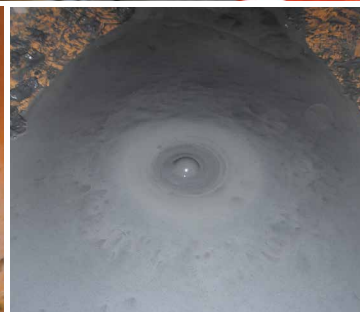
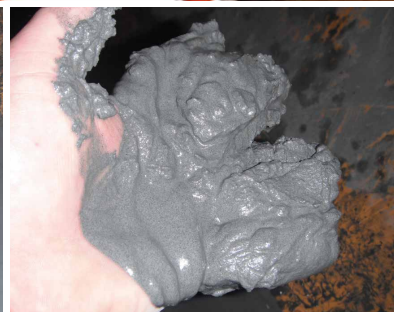
Above: Injecting to achieve leak-mitigation and re-support and re-level the pipeline. The ground around the pipeline had turned into sticky, liquid mud.

First, an on-grade laser level was established as a base line to monitor levels. Second, injection penetrations were drilled and engineered structural resins were injected to fill voids and confirm uniform support.

material, and to accurately control releveling results. Finally, the team stitched the joints around the circumference of the pipes to void fill, support and minimise any ingress of surrounding soils.
